**CONDITION ASSESSMENT OF THE CONFEDERATE  
POWDERWORKS CHIMNEY IN AUGUSTA, GEORGIA**

***JULY 2003***

INSPECTION OF 153' SQUARE RED BRICK CHIMNEY

Our File #CE-34190-C

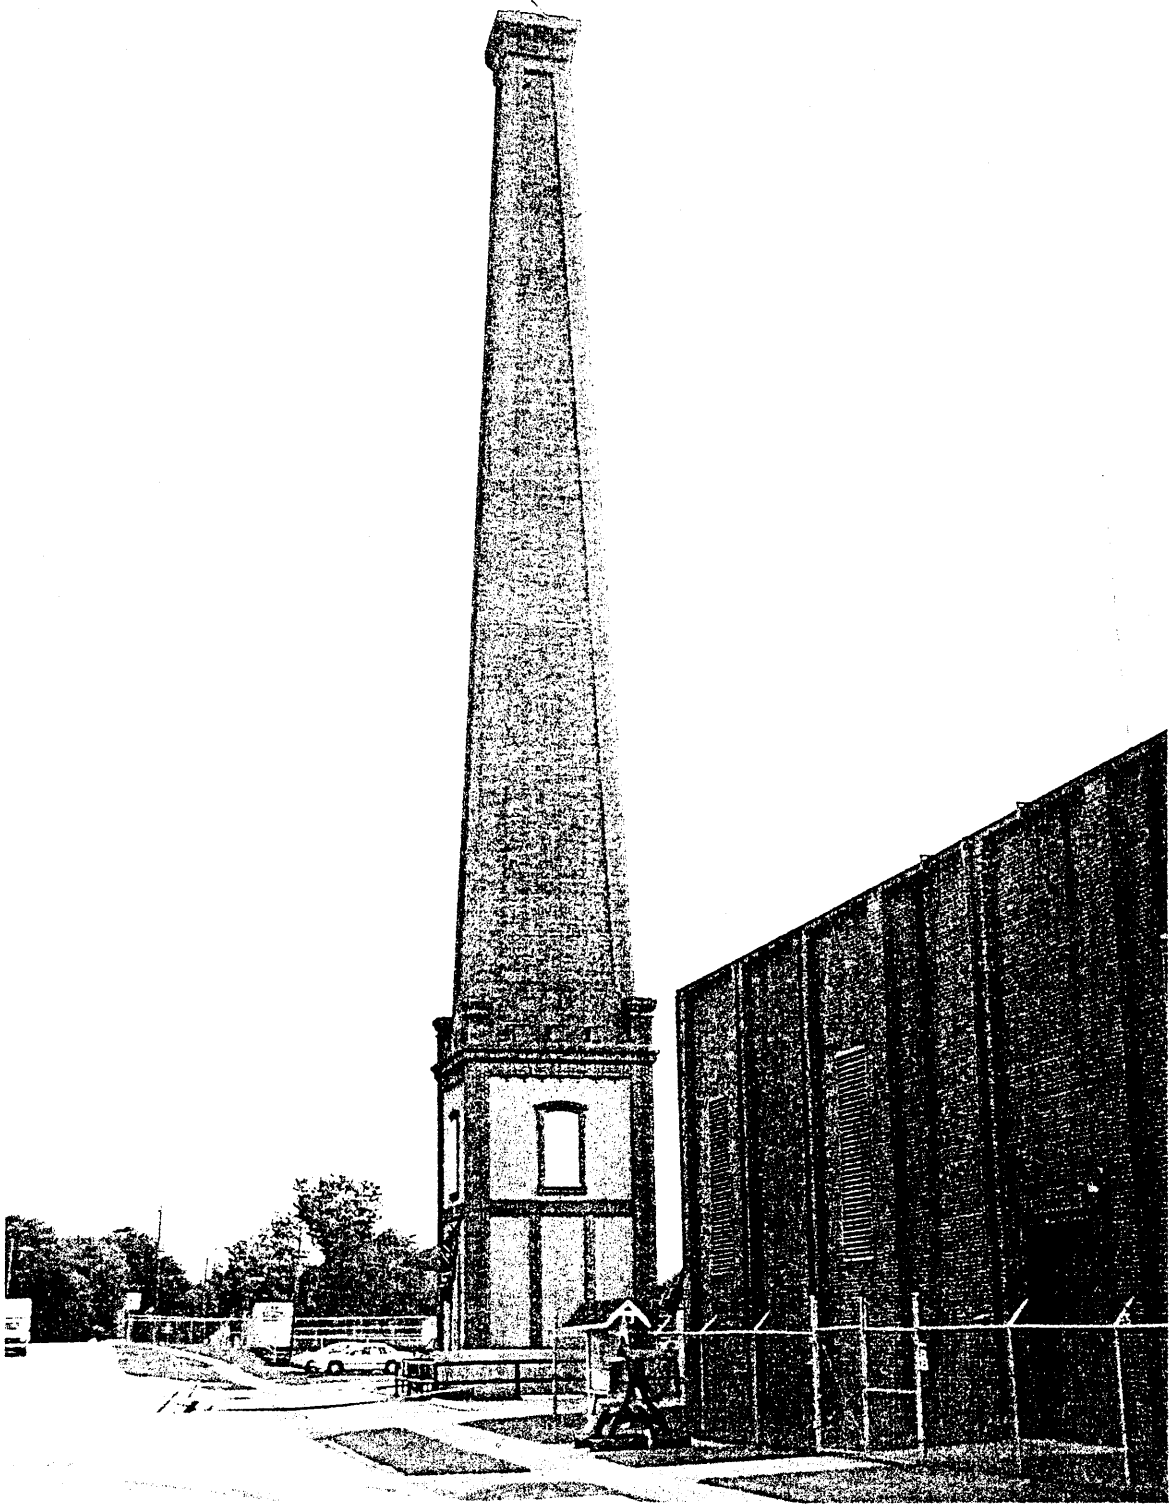
Photo #1: Overall view of the Confederate Powder Works Chimney
